December 9, 2024

This weekend was a turning point for the front parlor. The selective demolition work has now transitioned to putting the room back together.

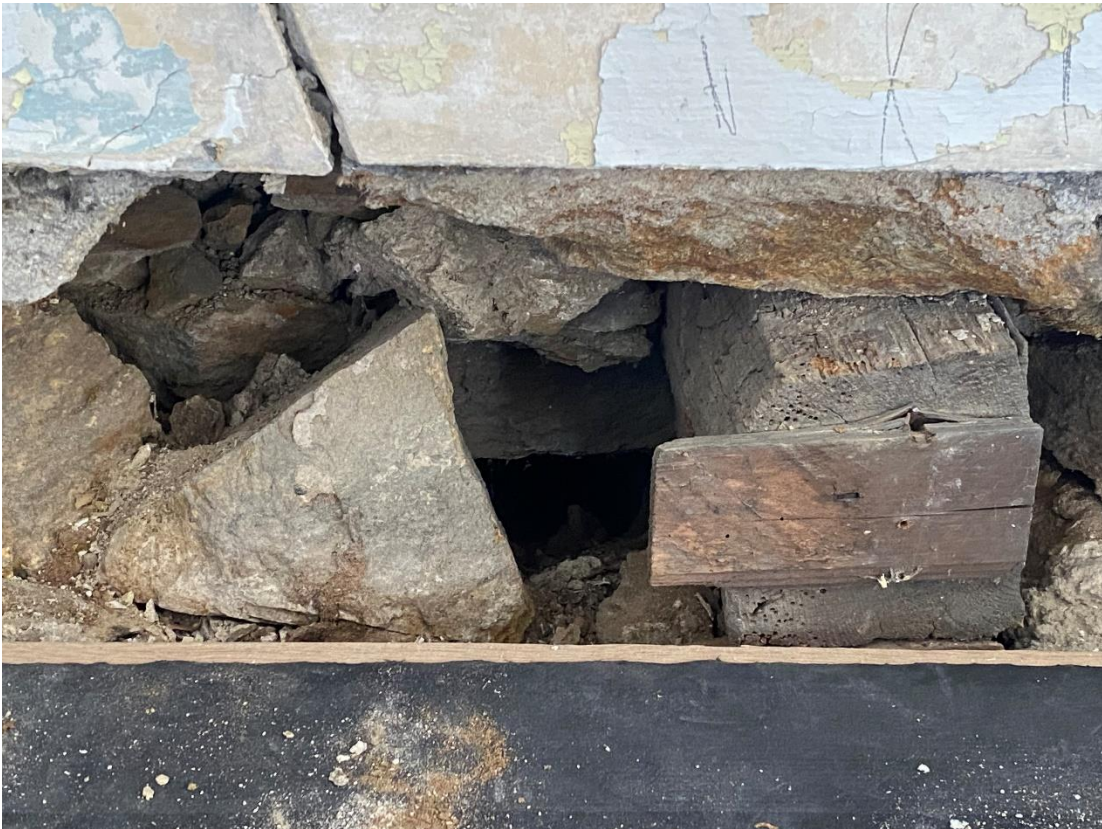
There was a large cavity in the stone wall under one of the front windows where you could see daylight into the cellar window well from inside the parlor. Loose stones were removed and reset into the wall and the gaps pointed with mortar. The paint below the chair rail on the exterior walls had come loose from the plaster so it was carefully removed down to a solid base. A bonding adhesive will have to be painted on the raw plaster before any additional patching is done.

Cavity in stone wall below front window. The wood block is the 19th century technique to mount the wooden trim to the masonry.

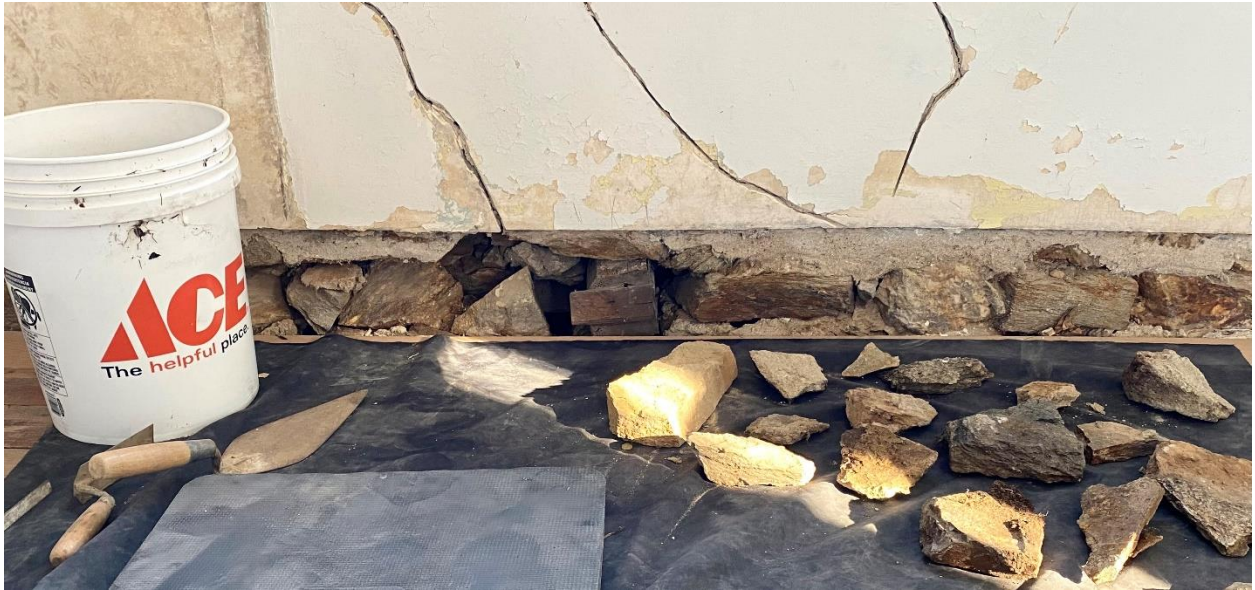
Loose stone was removed and the cavity vacuumed of dust and debris in preparation for resetting.

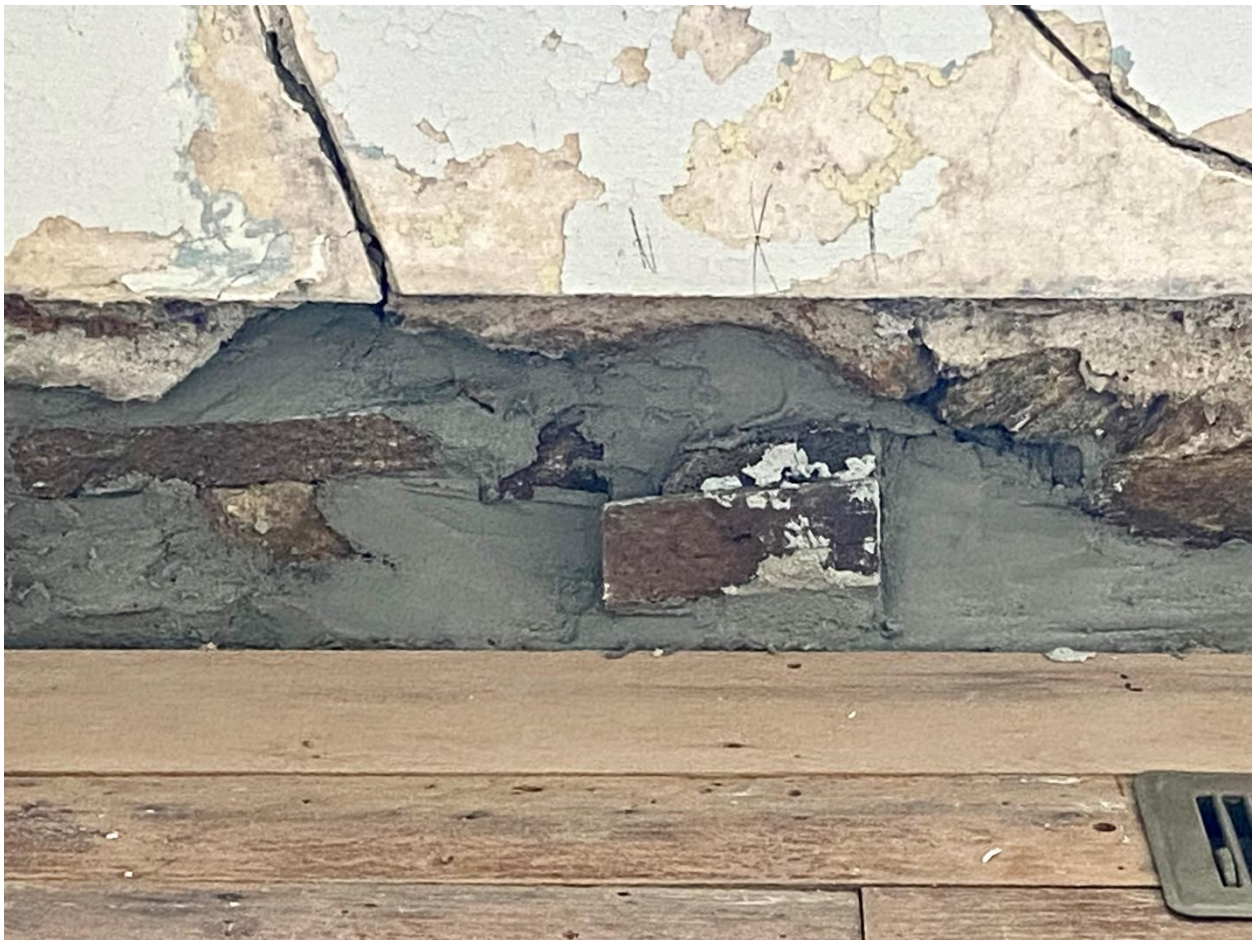
The stones were reset into the wall and gaps between were repointed with mortar. The wood mounting block for the trim was resecured.

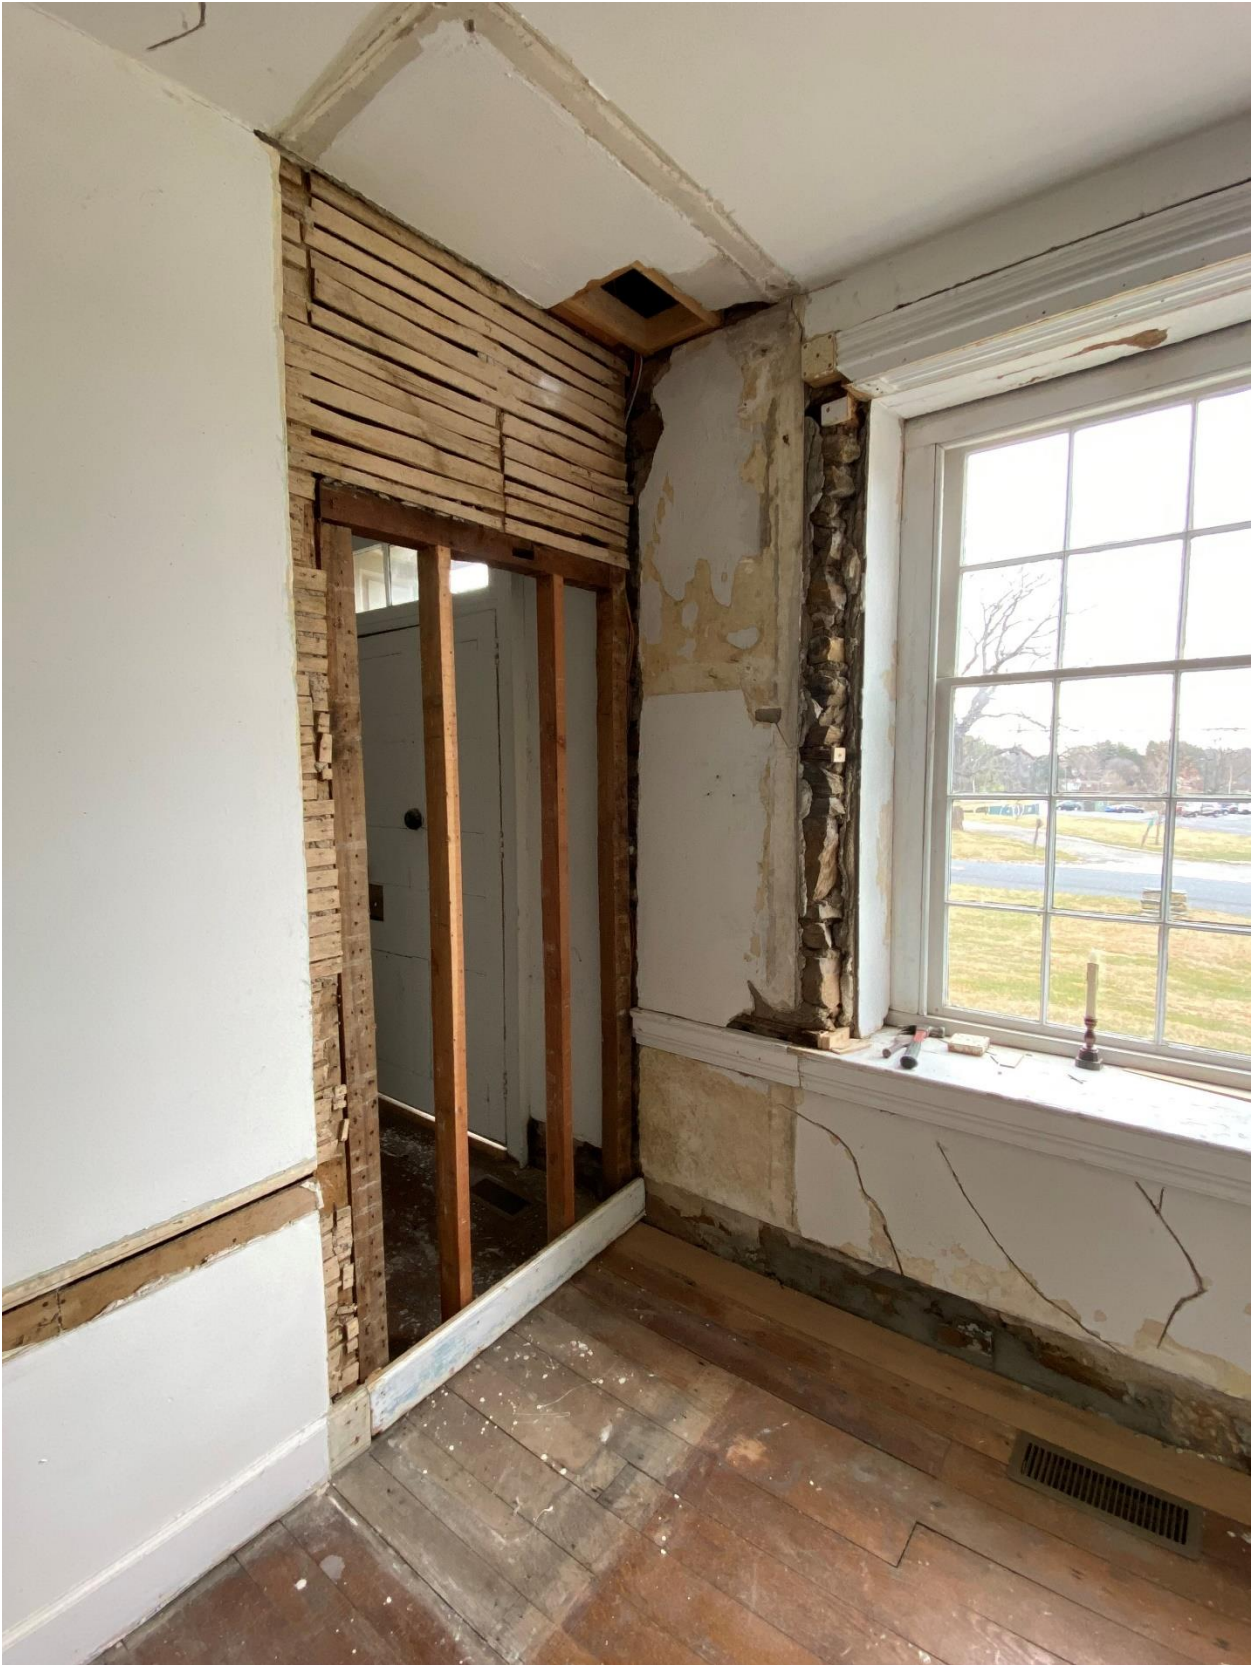
Front closet door opening infill "BEFORE"

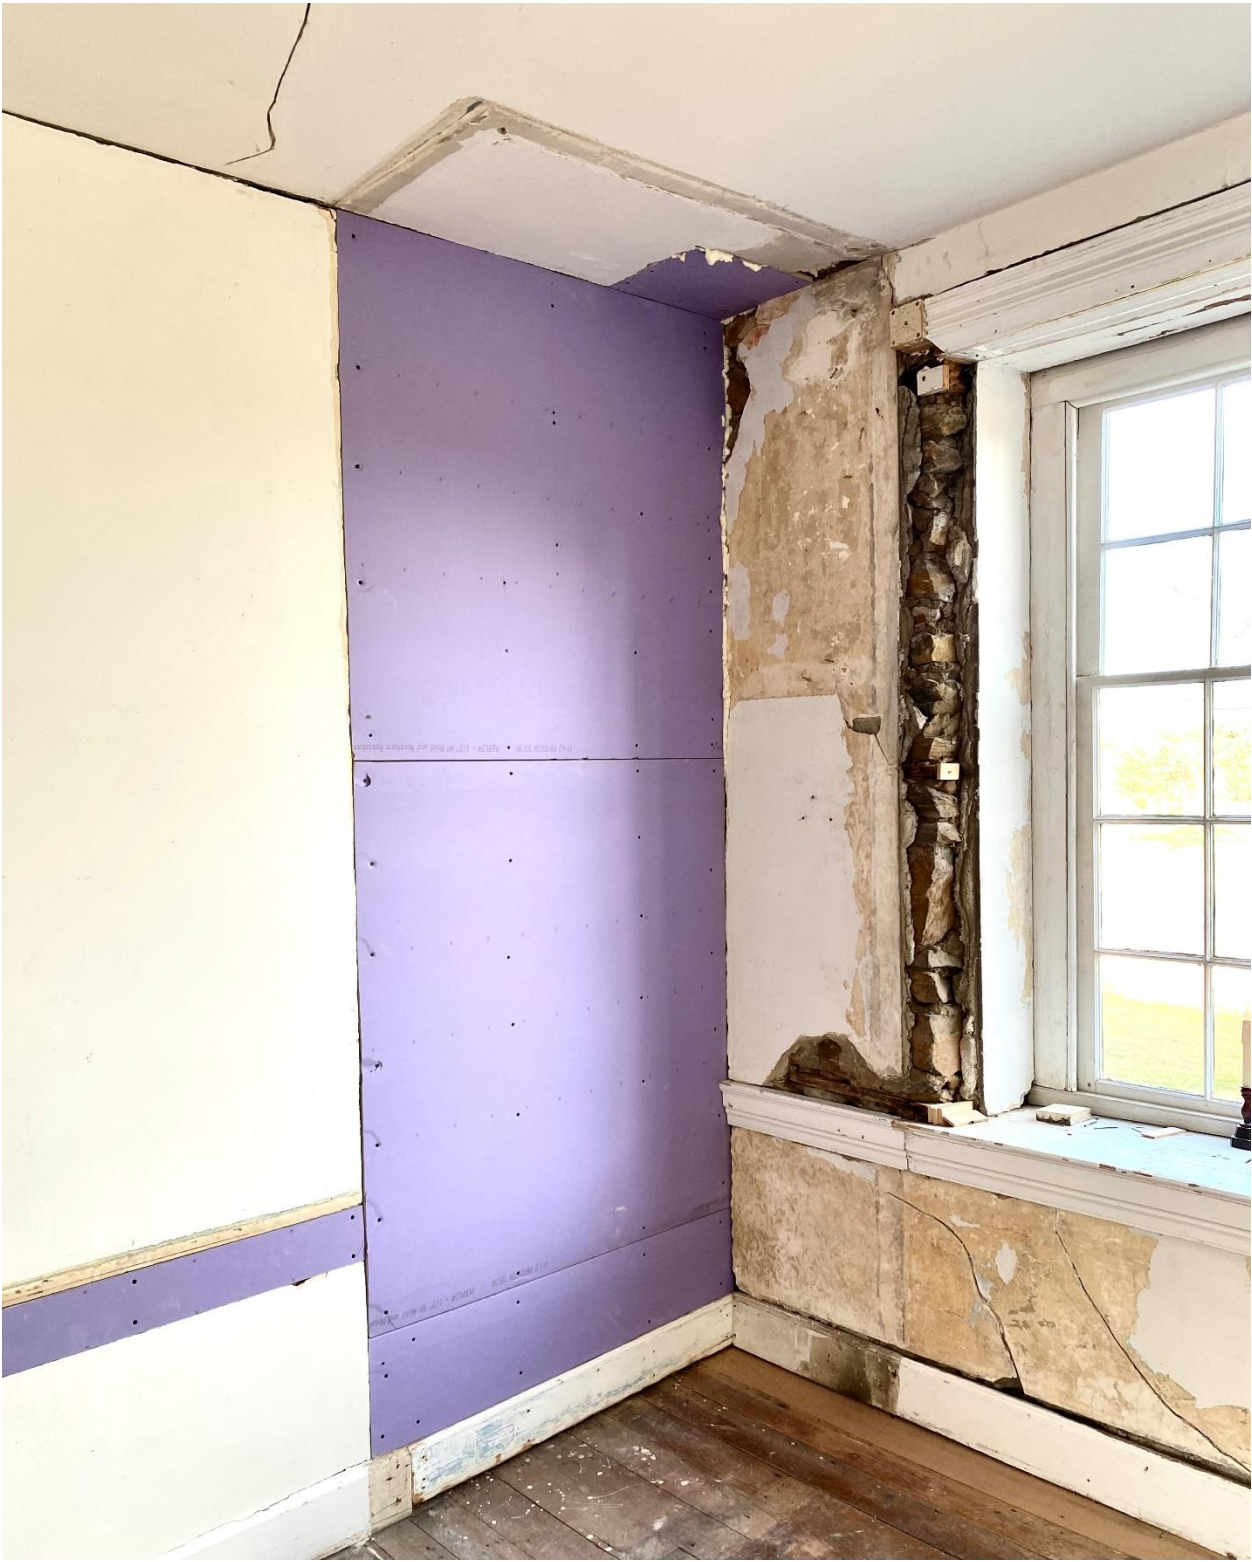
Front closet door opening infill "AFTER"

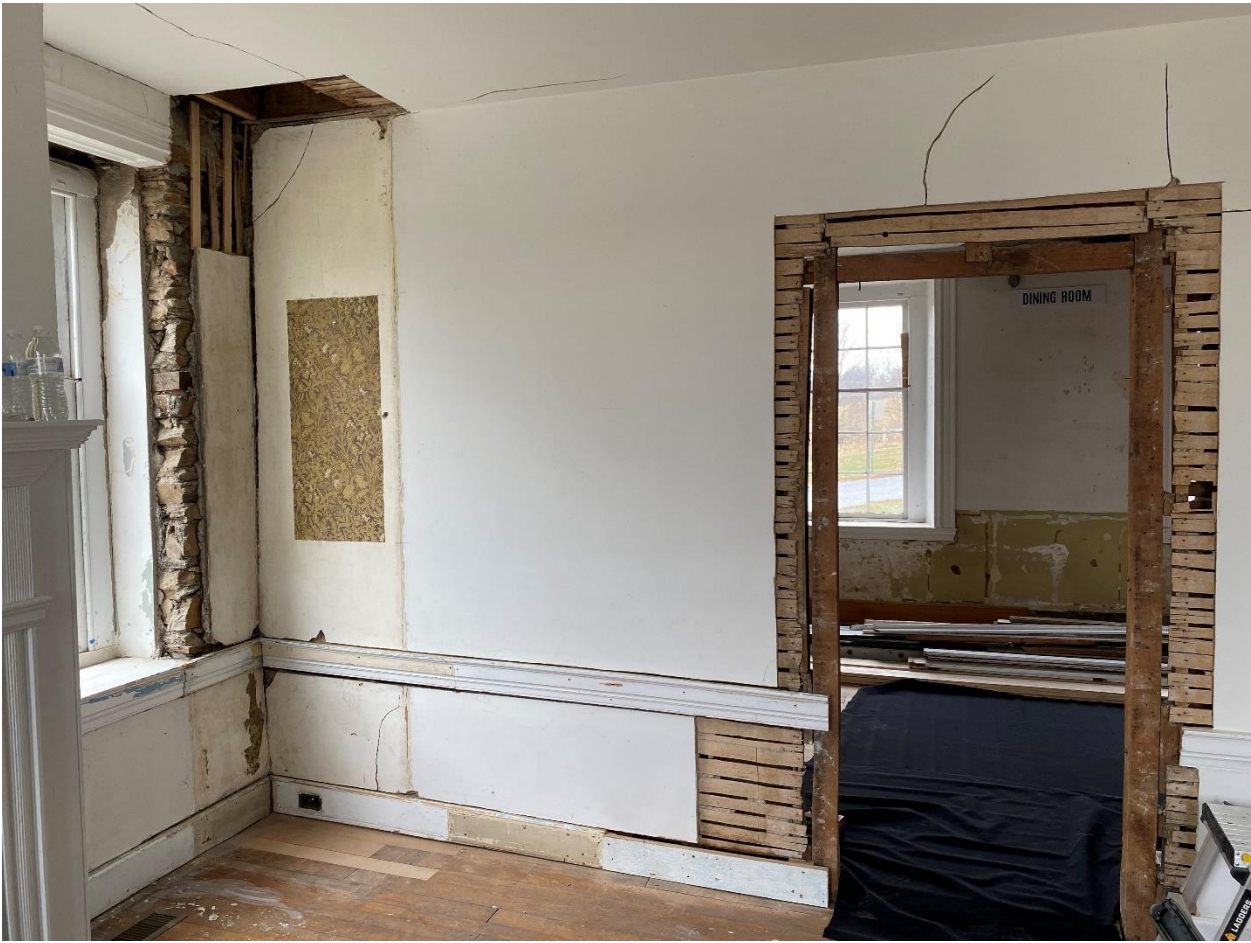
Center partition wall "BEFORE"

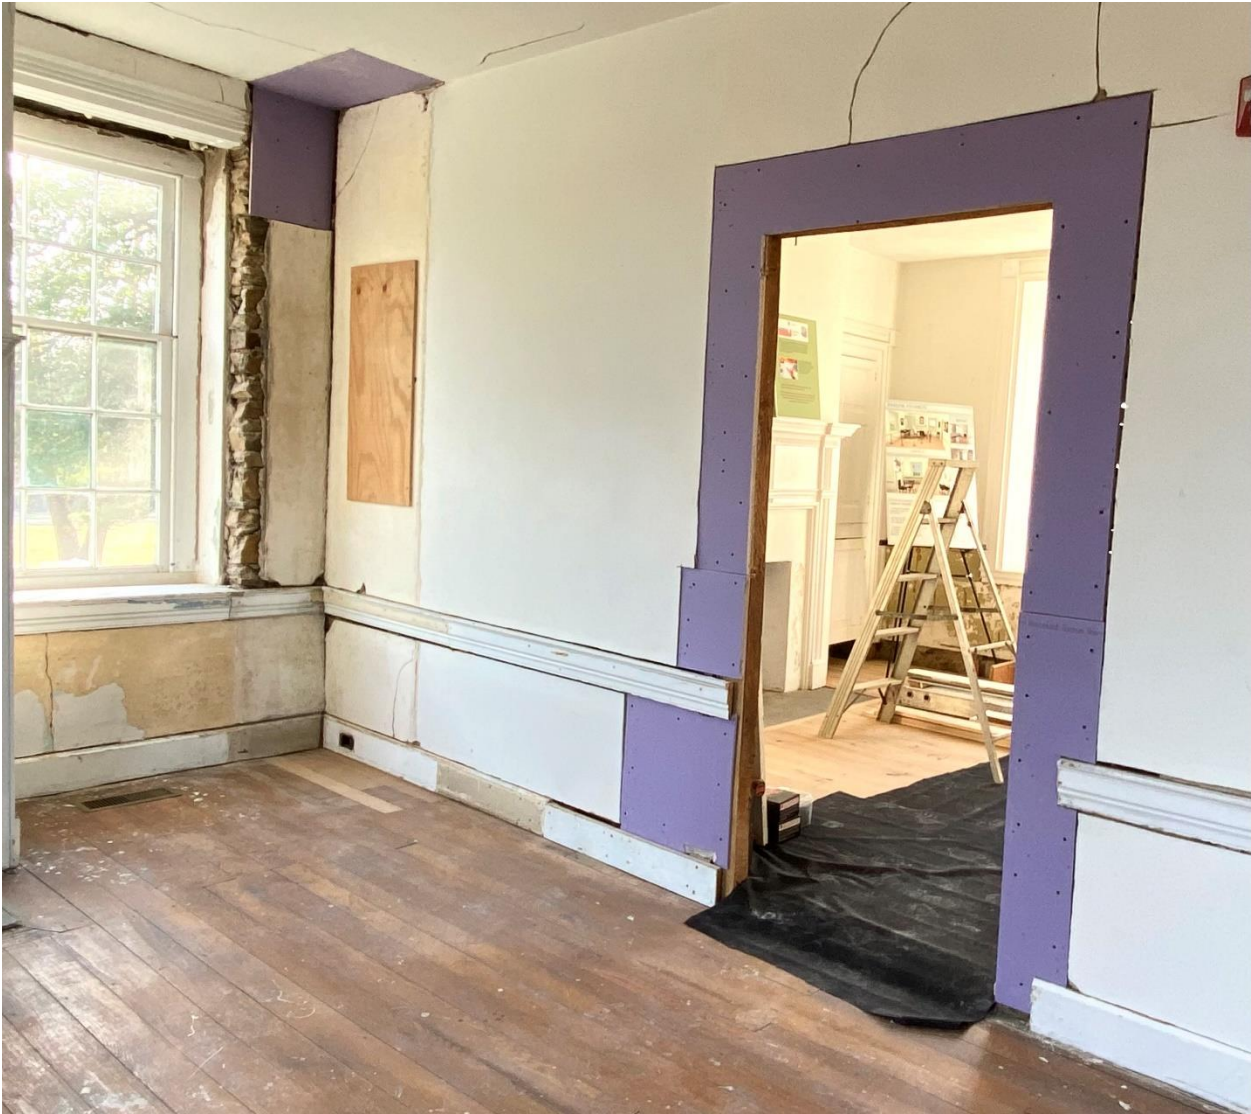
Center partition wall "AFTER". I covered the c. 1890 wallpaper panel with plywood to protect it during construction.

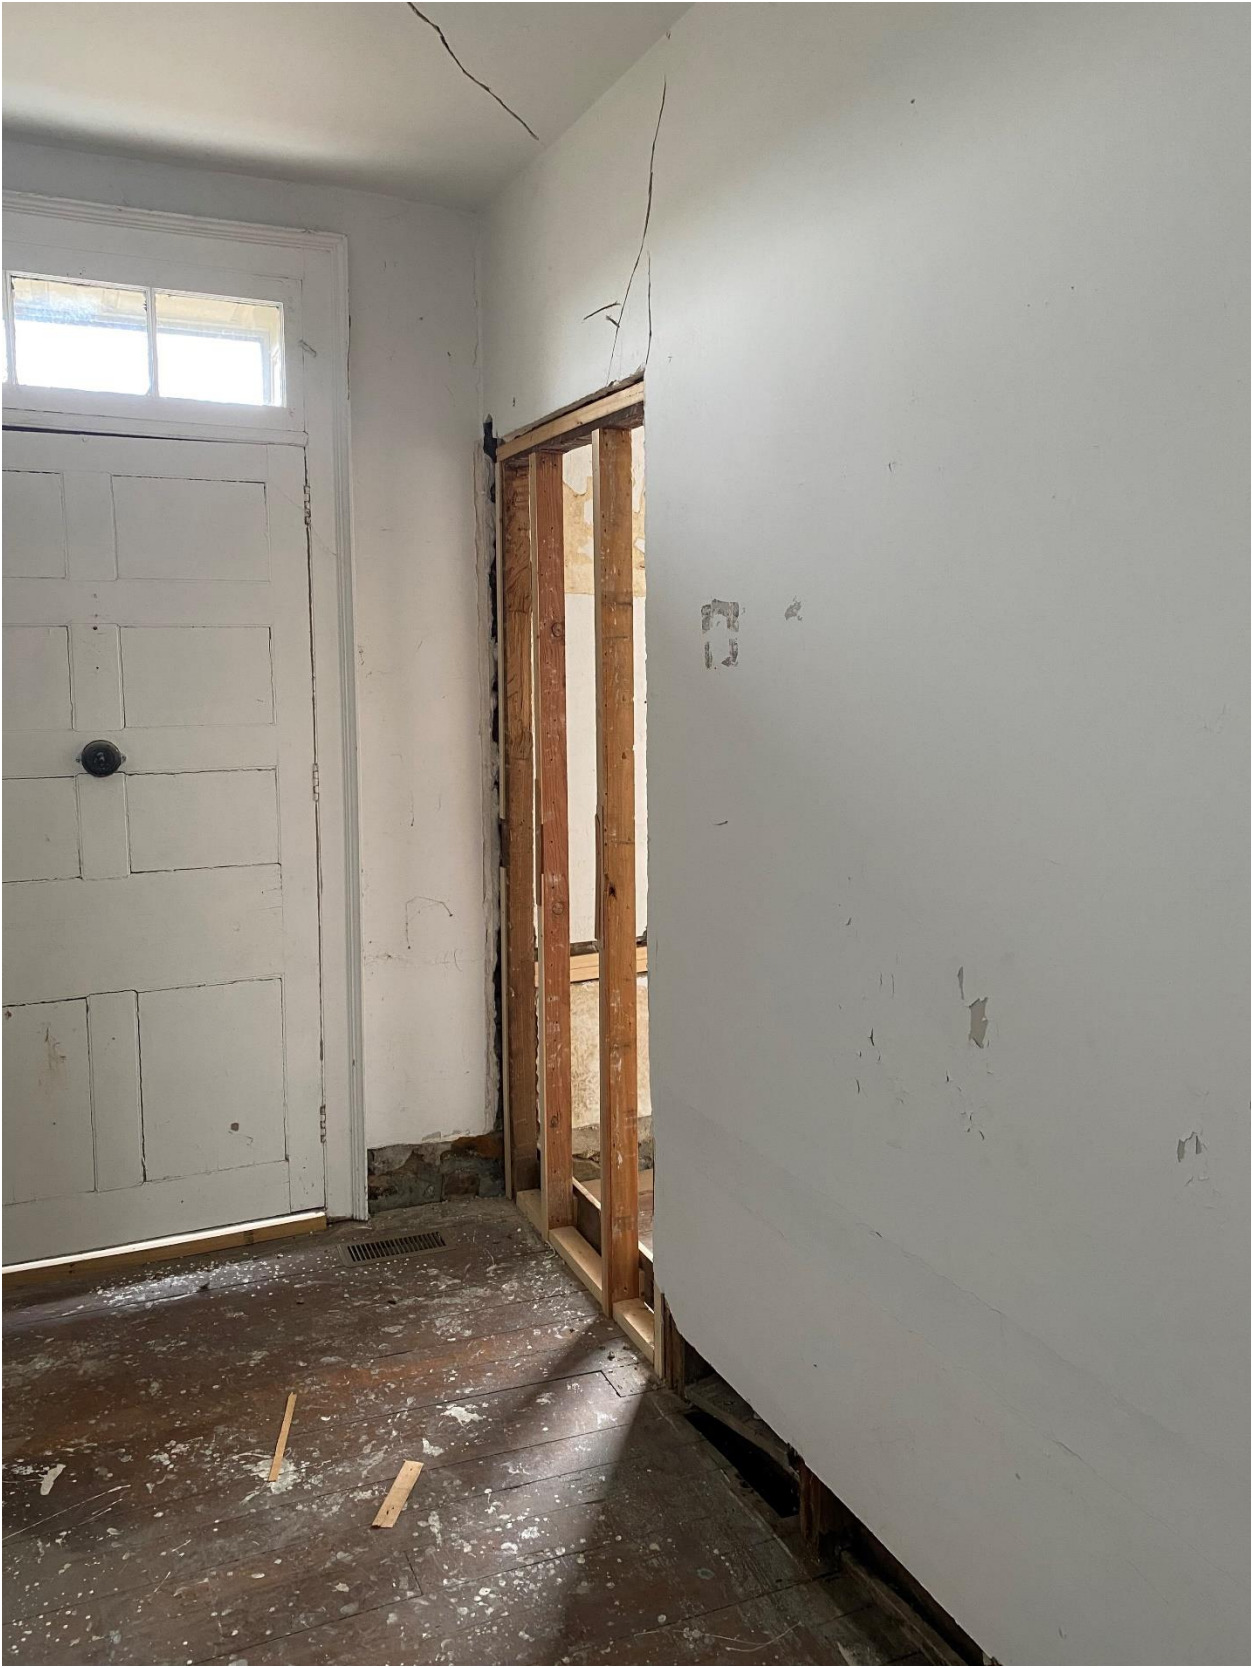
Front stair hall "BEFORE"

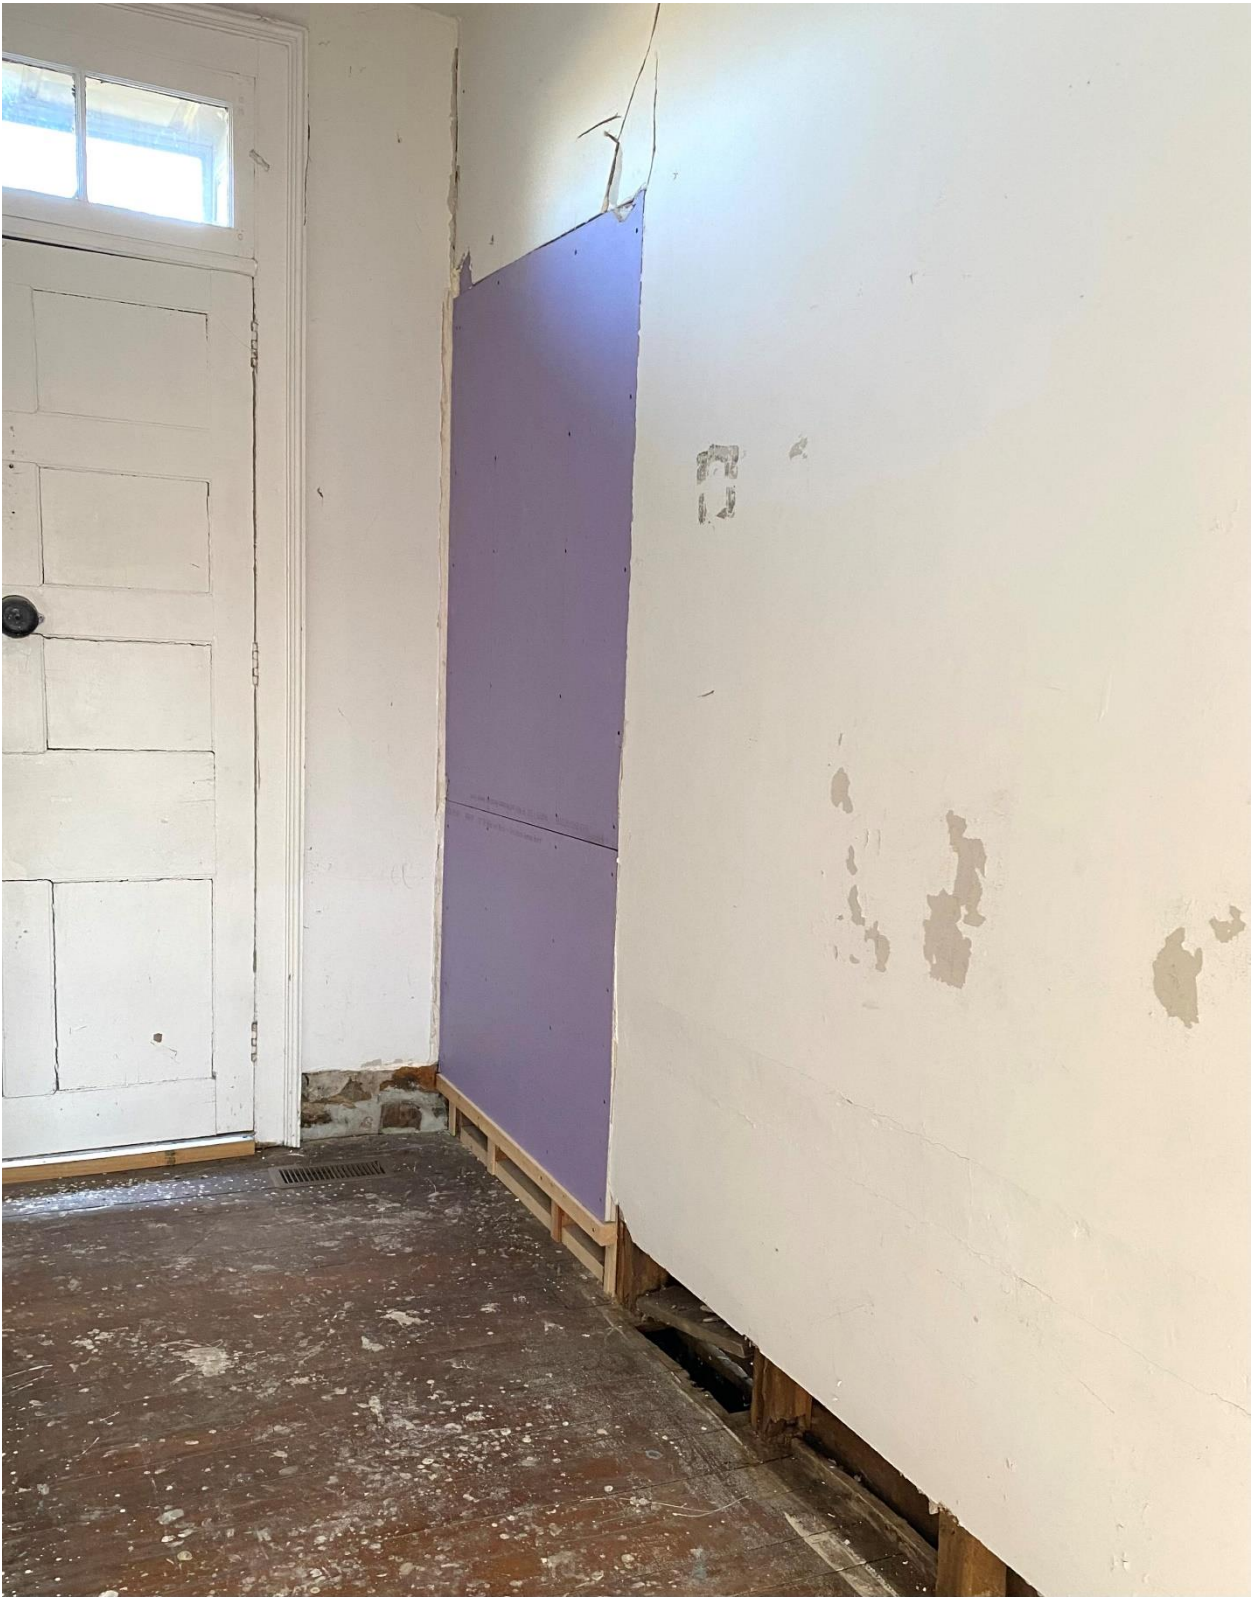
Front stair hall "AFTER". The stone wall where the baseboard was removed in the front wall was repointed.
