## Rediscovered Pass-through Window

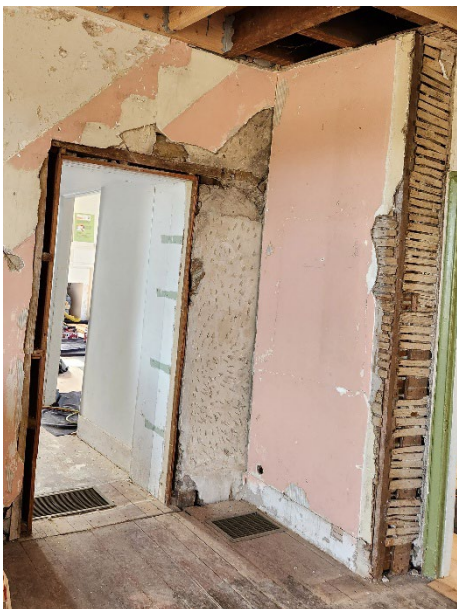
While working on opening a section of plaster to create a “witness window” to expose the hand split wood plaster lath we discovered that the plaster was applied over metal lath and gypsum board. This would have been done in either the 1940s or 1950s renovations. We stripped back a bit more and discovered an old frame of an opening leading into the built-in closet in the kitchen. After further investigation we determined that there was originally a small pass-through opening in the wall between the kitchen and Gathering Room. The

shelves have the same bead detail on both sides. To keep the plaster contractor moving forward we applied a temporary wood frame to be used as a plaster stop.

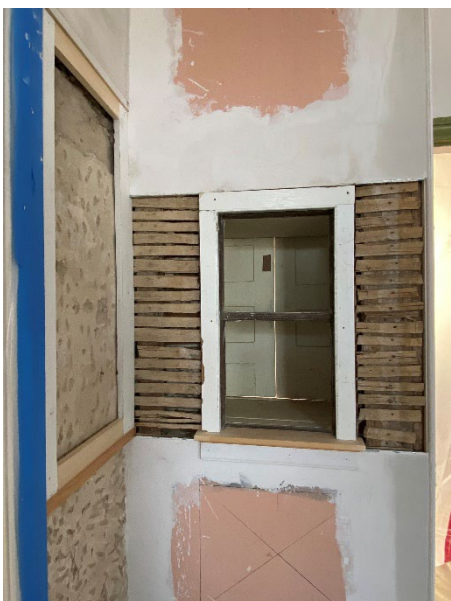
We carefully removed the old counter nosing (that had been previously broken off) to identify the style of nail used to secure it. This would allow us to determine if this was an original element when the addition to the house was constructed in 1841. We found machine cut square nails which would have been used in that period establishing that the opening is an original element. In the hoard of salvaged original moldings, we found casings taken from the former upstairs hall closet. These had originally started out elsewhere in the building and during the history of renovation were repurposed into the upper hall closet.

The detail of the bead is a match to the casing on the kitchen side of the built-in closet so it is an appropriate style that could have been present in the Gathering Room. We recreated a sill and cased out the opening based on clues left on the old frame.

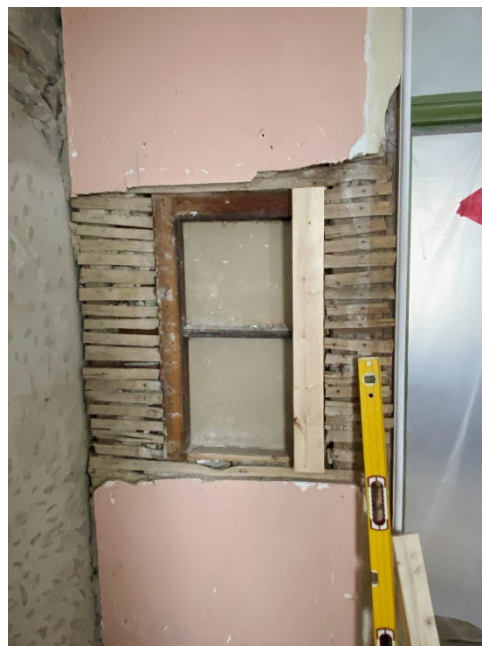
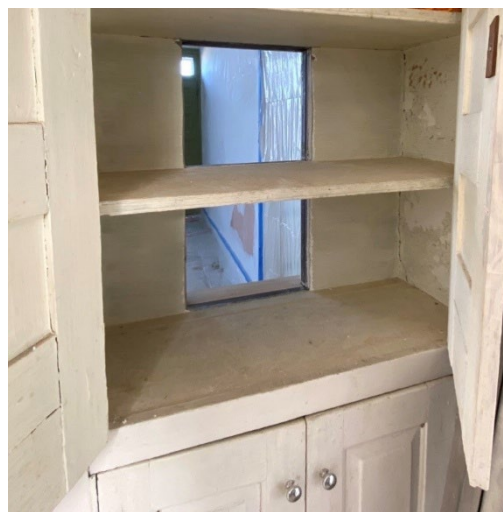
Since we had the opportunity to display original materials from 1841, we also created “witness windows” to show the early hand split oak plaster lath on either side of the pass-through.

On the wall to the left we created a wood frame to display the early exterior plaster material. This material extends behind the partition wall in the c. 1841 addition giving evidence that the c. 1829 house was originally plastered over the exterior stone.
