## **1829 Parlor Floor Repairs**

The flooring repairs where the 20th century air ducts were once located has been completed. Part of the difficulty of the job was to get the original materials out and cut without damage. I ended up carefully removing the baseboards as there was no other way to get the flooring along the wall out. I had to add support blocking in places to carry the new flooring. The "art" part of the job was to try to keep original flooring adjacent to original flooring as much as possible. Where "new" antique white flooring had to be used I chose boards with similar straight grain to best match the original boards in the room. Once the floor is sanded I think the materials should blend together when finished.

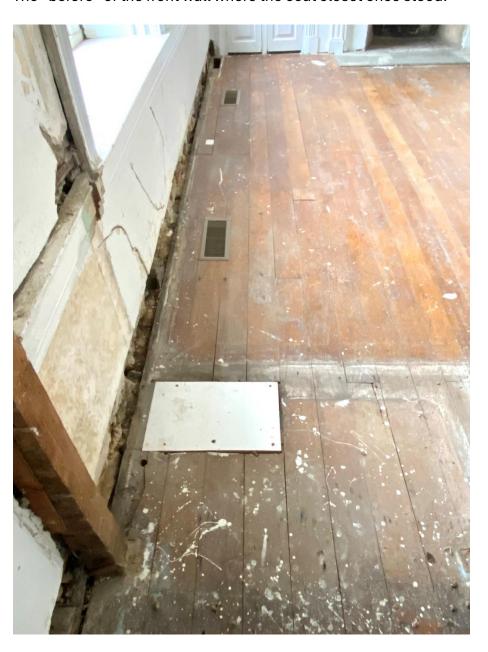
The "before" of the front wall where the coat closet once stood.

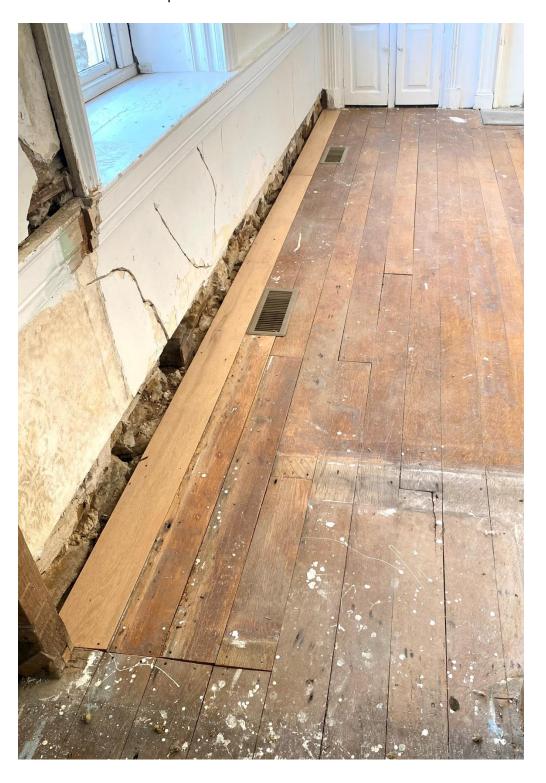
The "after" in the same location using some original boards and some "new" antique white oak flooring with similar grain. The wall infill in the former doorway will cover the joints in the floor that all line up.

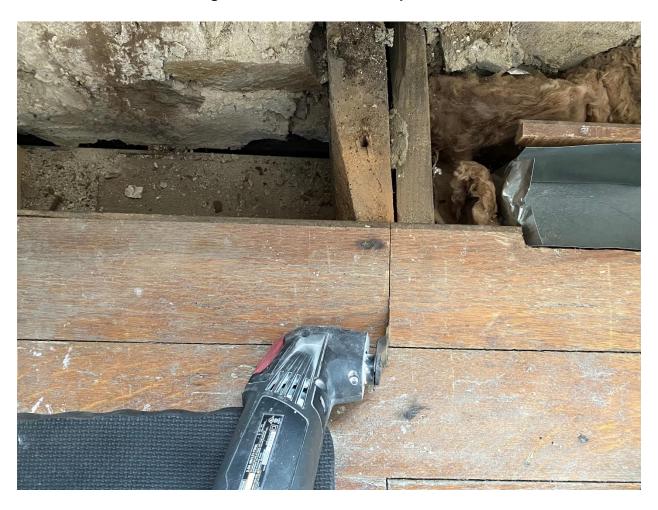
The boards had to be carefully removed and cut to join over the floor joists. Since there was a narrow air duct hole and former floor outlet hole that needed repaired anyway, I used the original row of flooring along the wall to infill where the large air duct once was located. This allowed for the most original material to be used adjacent to each other.

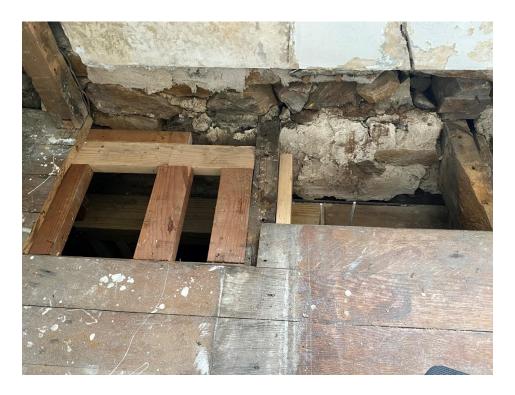
Support blocking had to be installed to carry the flooring where the former doorway and air ducts were once were located.

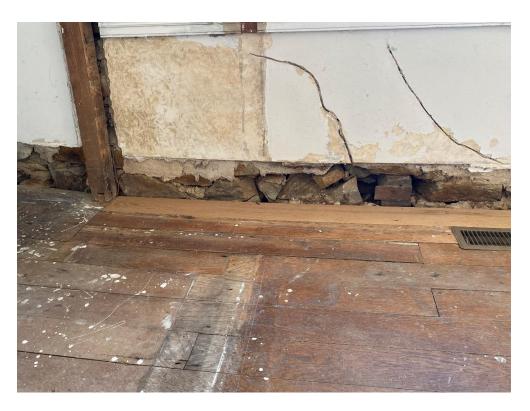
The flooring joints were staggered to give a more pleasing appearance and disguise the repair. Wood with similar grain was chosen. Once sanded and finished the area should blend well.

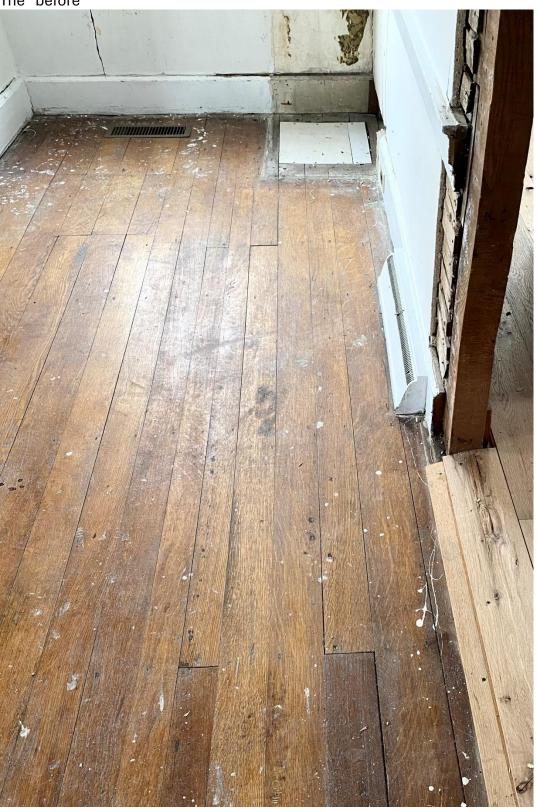
The floor in the opposite corner was also repaired. There were several duct holes that had to be removed.

The "before"

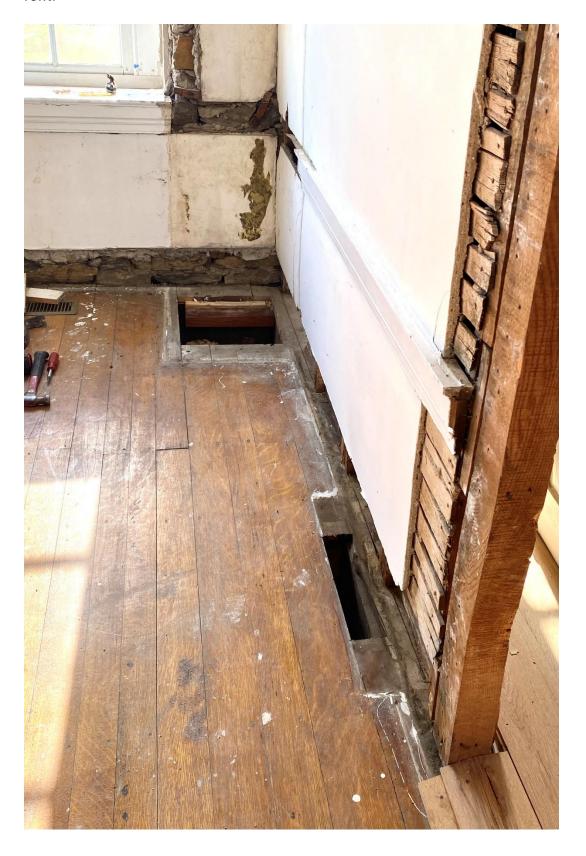
The baseboards had to be carefully removed to be able to get the flooring boards out and refit.

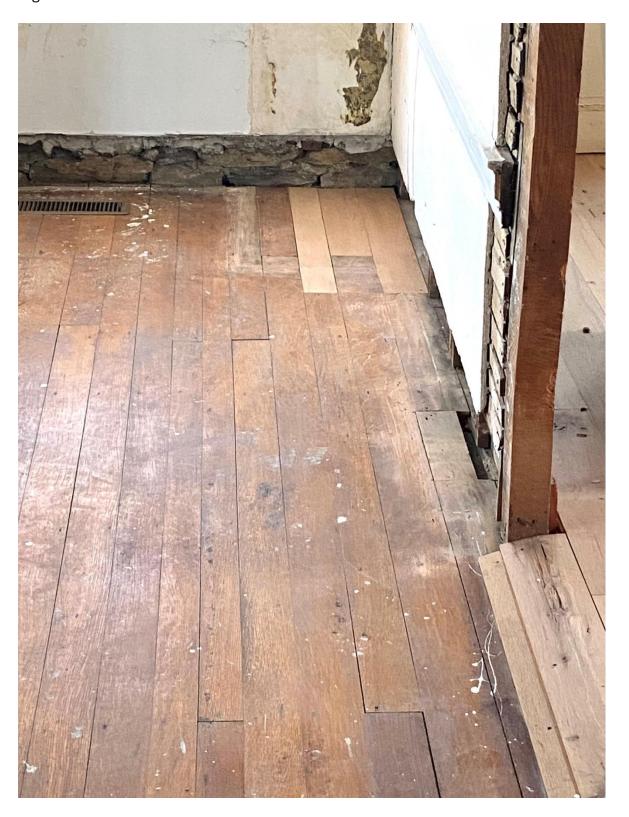
The "after". As with the front repair, original material was used adjacent to other original material. Where original material was not available, "new" antique white oak flooring was used with similar grain pattern. Once sanded and finished these boards should blend together.
